VISSCHER LUMBER INC.

TEST REPORT

Report of testing Vision Sidewall Shingle Panels for compliance with the applicable requirements of the following criteria: **SFM Standard 12-7A-1** – *Materials and Construction Methods for Exterior Wildfire Exposure – Exterior Wall Siding and Sheathing.*

REPORT NUMBER
104526405COQ-002

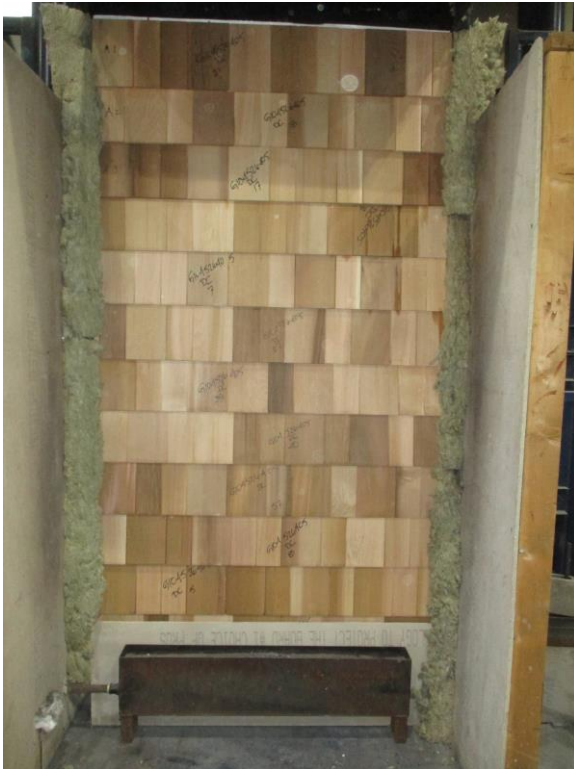
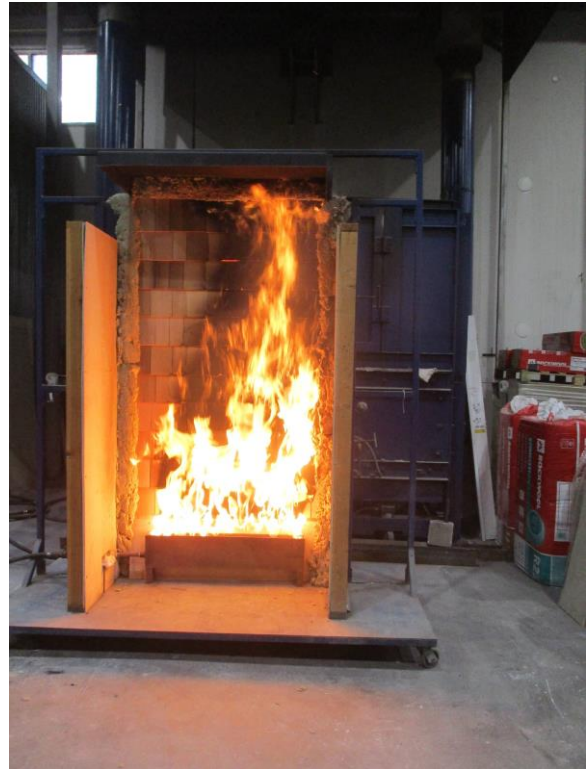
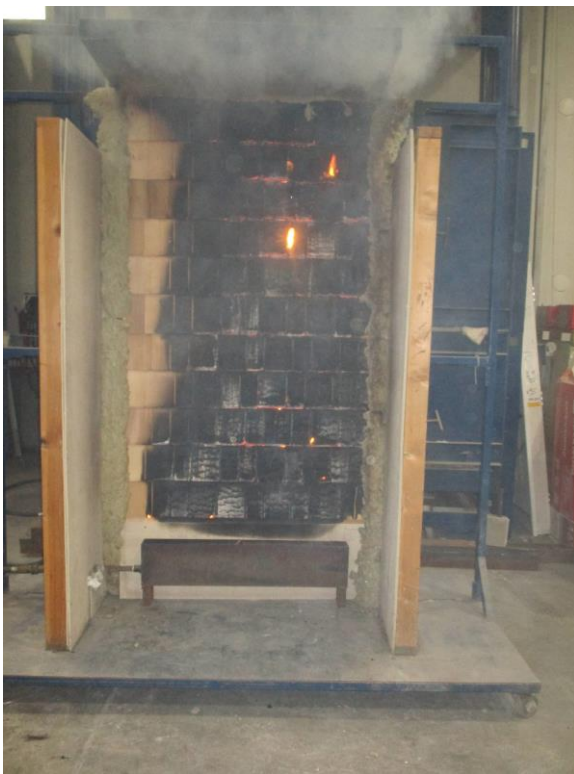
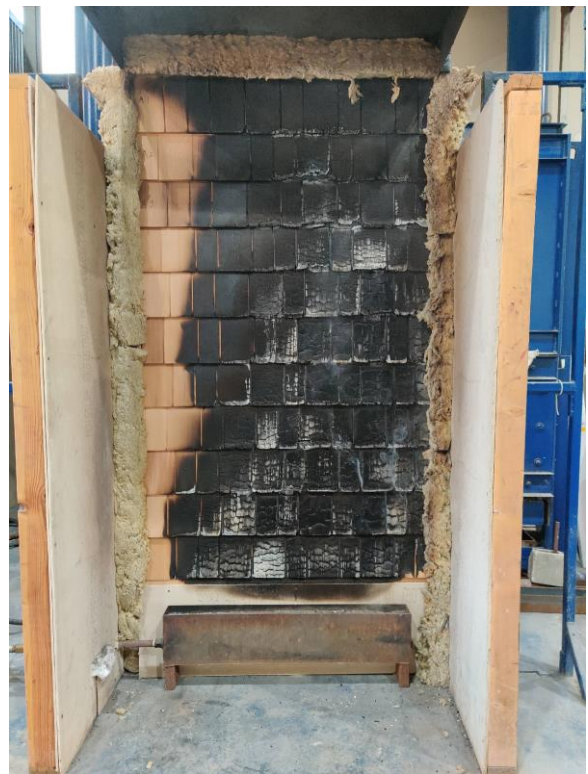
Test 1

Time	Observation
0:00	Start of test.
0:28	Crackling sounds and discolouration begin.
0:53	Ignition of surface.
2:11	Flaming spread along right side of sample.
4:20	Right side charred.
5:08	Ignition at centre of wall.
6:43	Left side ignition, spreading along wall.
10:00	Burning stopped. Flaming on sample remains.
11:50	Glowing remaining on surface. Smoke behind left stud on unexposed surface.
21:00	Minor glowing remaining on surface.
29:00	Only glowing remaining at mid-bottom area. Smoke remains.
34:24	No glowing on surface. Only smoke release.
39:30	Bottom right quadrant releasing smoke.
50:00	No change to unexposed surface. Warm to touch.
63:00	Smoke continues at bottom right. No change to unexposed surface.
70:00	End of test.

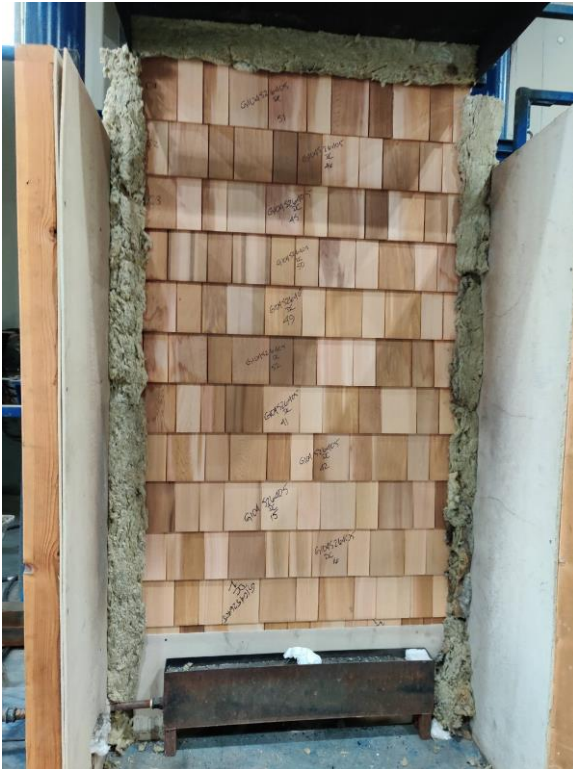
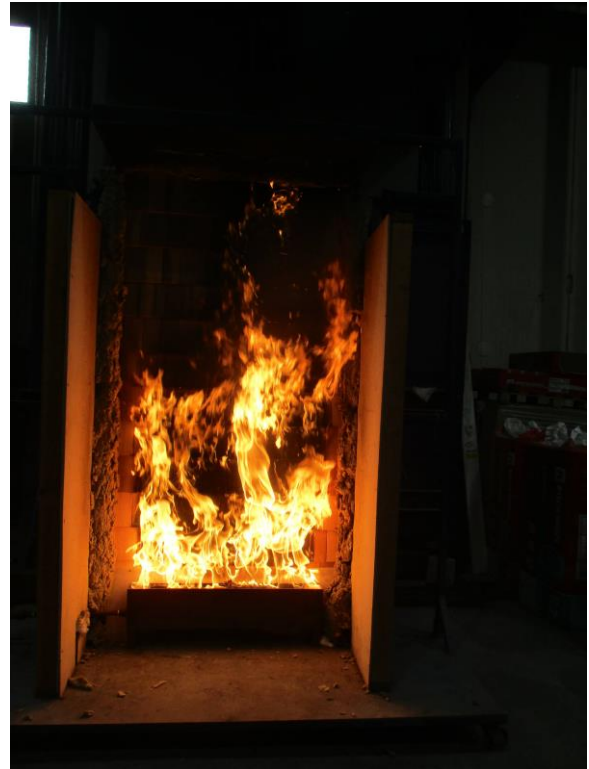
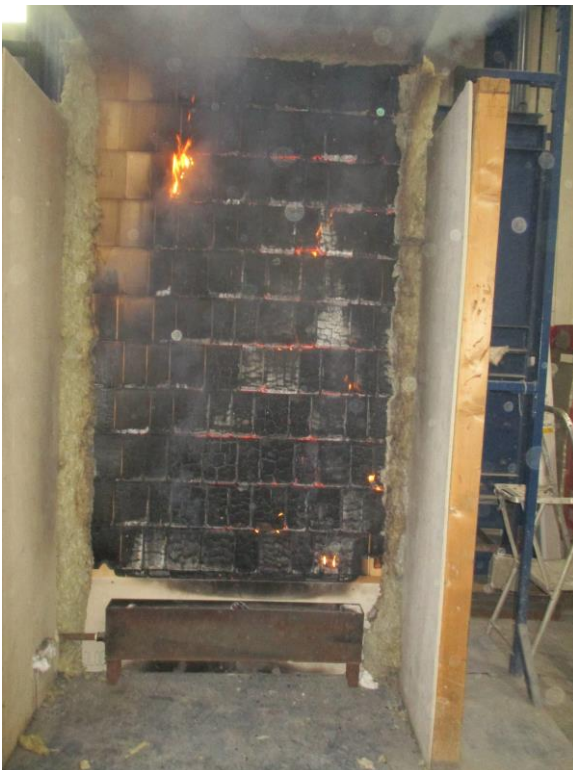
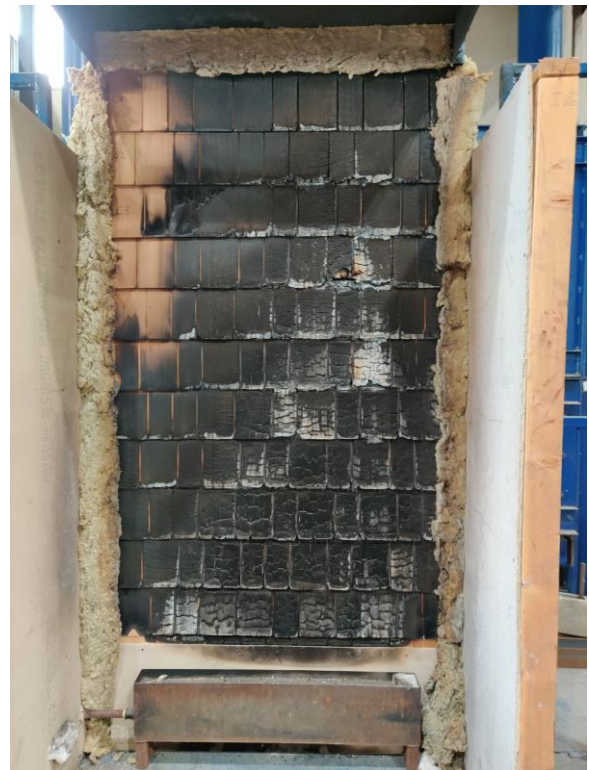
Test 2

Time	Observation
0:00	Start of test.
0:48	Discolouration on surface.
1:15	Surface ignition.
4:24	90% of surface charred.
10:00	Flaming on surface continues after burner stopped.
14:30	Minor flaming remains on surface.
21:14	Minor glowing on surface.
26:28	Only smoke remaining on surface. Unexposed surface warm to touch.
42:00	Smoke reduced.
70:00	End of test.

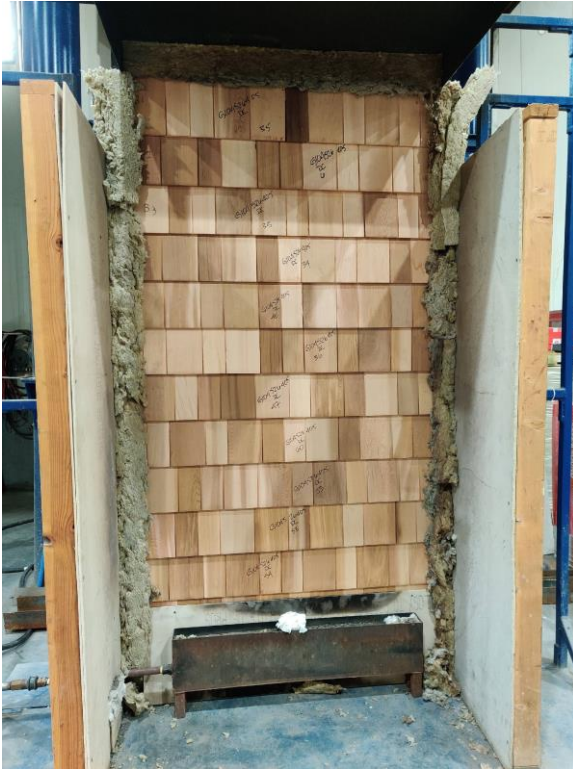
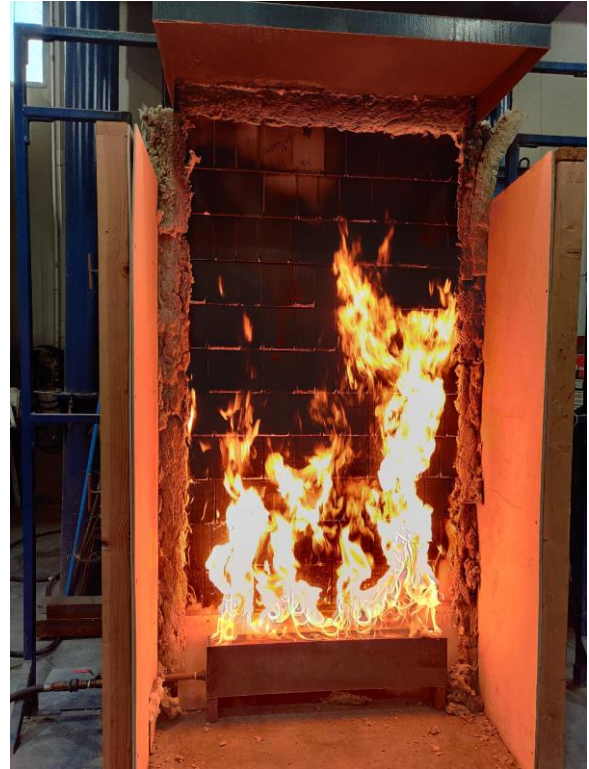
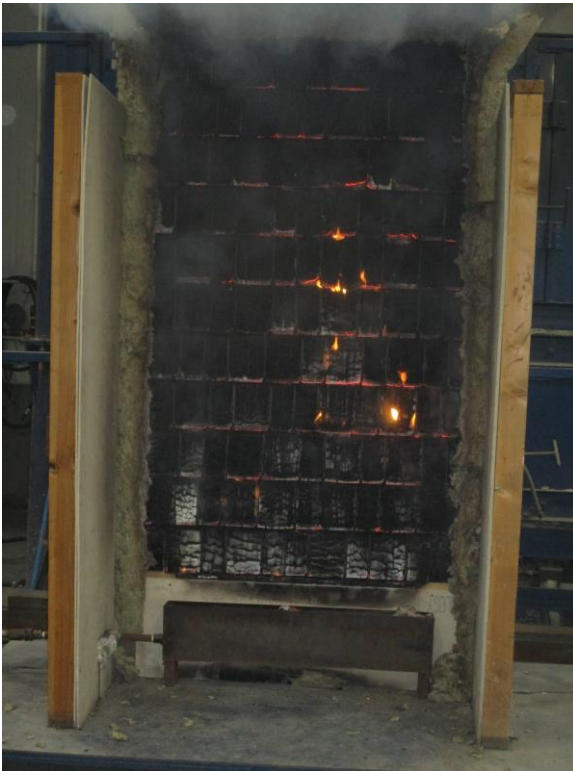
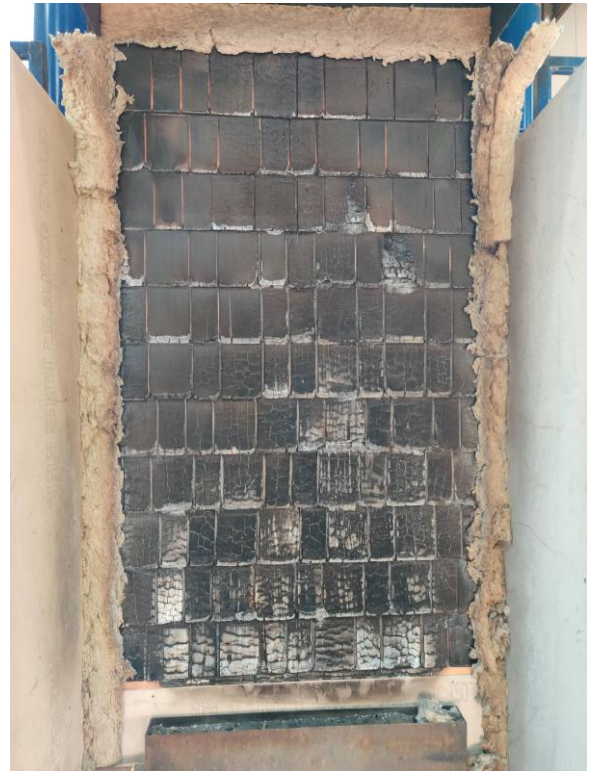
Test 3

Time	Observation
0:00	Start of test.
0:41	Discolouration and popping.
3:04	Surface charred.
10:00	Flaming on surface continues after burner stopped.
12:17	Centre surface charred.
15:40	Flaming at mid-right.
28:29	Only smoke remains on surface.
40:00	Minor smoke remains. No change to unexposed surface.
48:00	Specimen stable. Light smoke.
58:00	All reactions stopped. End of test declared.
